GXS-700 X-ray Sensor Part 2

John McMaster JohnDMcMaster@gmail.com

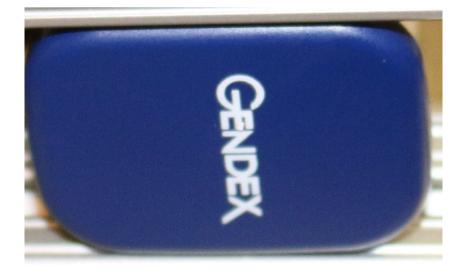
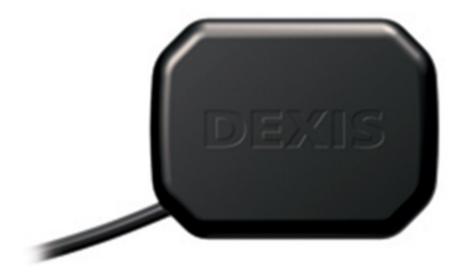
- Gave mtvre talk 3 years ago
- Made FOSS Gendex GXS-700 size 1 tools
- Same hardware in Dexis Platinum (right)

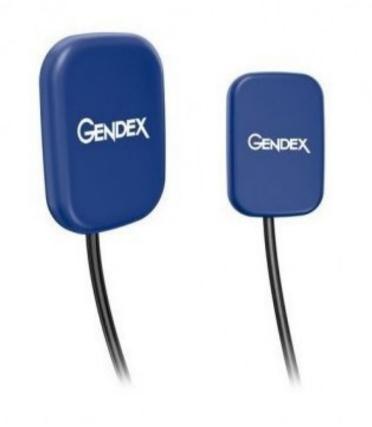
- Small size sensor for children ("size 2")
- Not supported since I didn't have a sensor
